## REAL CASES OF OCCURRENCE OF UNTYPICAL BRITTLE RUPTURE OF STEEL COMPONENTS DUE TO BENDING STRESS

**Keywords:** embrittlement of steels, thin-walled components, retained austenite, martensite

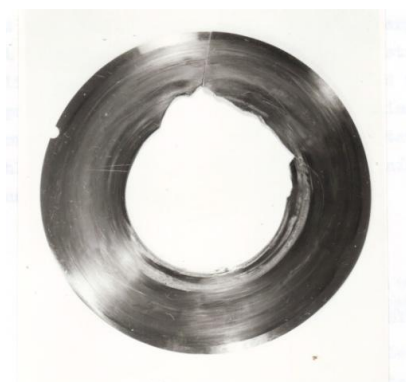
**Fig. 1** Pressure plate [1]

After seizing the hydrostatic converter, there was the destruction of the component. The subsequent analysis of the accident showed that plate was not installed horizontally. Due to dimensional inaccuracies in assembly, the given plate was installed under an unspecified small slope. Component was not only exposed to pressure loading, as it was determined by designer, but there was also the bending loading [1, 3].

Component was broken through the whole diameter. Inter circumference was ruptured in one area. Surface of both front functional areas of the pressure plate showed traces of thermal and mechanical influence circa 5 mm and it was from the outer circumference up to inner circumference [1, 3].

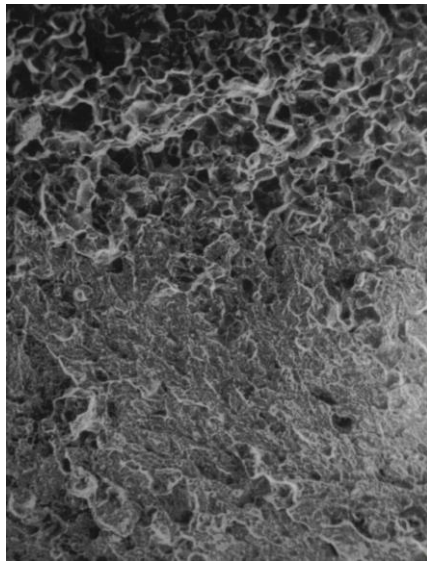
Micromorphology of the original fracture surface was mostly formed by intergranular fissile (IGF) rupture in a thermally and mechanically uninfluenced area. According to this finding, laboratory fractures were prepared and it was carried out by impact bending breaking of unnotched samples from these areas. In the case of these samples, there was observed band in sub-surface area (in the area of pressure loading) and this band was only with IGF facettes and it was along the whole width of sample (Fig. 2, 3). Towards to core, the mechanism of fracture was changed suddenly and it was the break moment where the mechanism of fracture was transgranular pit fracture (TGH) and it was towards to opposite side of surface (Fig. 2) [1, 3].

X-ray analysis was used for determination of content of retained austenite to  $13.0 \pm 1.5\%$ , while the usually accepted content of retained austenite for this steel is up to 5% [1, 3].

*Fig. 2 IGF + TGH fracture, zoom: 105x [1]*

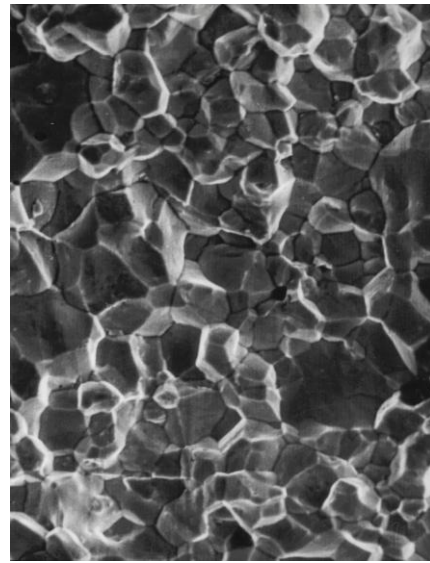
*Fig. 3 detail of Fig. 2, zoom: 350x [1]*

For an explanation of the mentioned untypical problem, the following conclusion was created. Because the given material contains a very high content of retained austenite, this austenite could be transformed to martensite because of loading of pressure plate by bending loading and it could be caused by incorrect mounting during installation. Mentioned mistake during the installation caused that there was the occurrence of intergranular fissile fracture. On the base of obtained results and from the diagram of dependence of hardening temperature as well as content of retained austenite for materials sheet of material 16 270 on parameters hardening, listed in the standards, we concluded that the pressure plate was incorrectly hardened [1, 3].

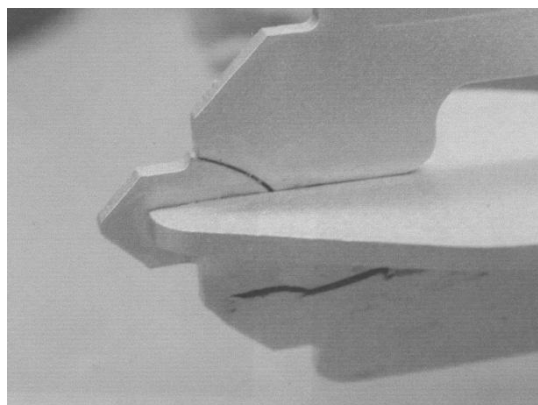
Other component, at which we observed mentioned rupture, is component called rib (Fig. 5). This component is part of assembly for harvesting and it was made of a material DOMEX 044 alloyed by boron. It consists of two semi-products of thin sheets of which the mutual seam was made up by pressing in [2, 3].

The several samples were prepared with original cracks of defective ribs and of suitable ribs. Samples with the original cracks had significantly heterogeneous, granular, acicular microstructure which was comprised by tempered martensite or bainite. Grain size was evaluated by degree 5 - 6 according to standard STN 42 0426. In the case of the defective ribs, the microstructure was mild heterogeneous, fine with significant needles and grain size was of 8 to 9. For samples of suitable ribs, the microstructure was fine, grained, homogeneous and it was composed of low-tempered martensite and grain size was 10 [2, 3].

*Fig. 5 Cracked rib [2]*

The obtained results were used for specification that in the case of defective samples there were not complied optimal conditions of heat treatment and the result was concerned with the increase of content of retained austenite. According to our opinion, similar mechanism initiated brittle cracks, which are comparable to cracks in the previous case. It means that the occurrence of crack is closely connected stress impact where the given stresses occur due to pressing in or due to welding because of heat-deformation cycle. We can suppose, that cracks are formed as late, it means that they occur some time after installation or welding [2, 3].

After determining of crack occurrence in this component, weld joint was designed. The variant of seam scoring was used because these cracks were still detected and it was caused either by exploitation or after a prolonged storage period. The cracking has not been already occurred after this change, which had minimized internal stresses in the material. Simultaneously, the evaluation of microstructure and fracture helped to propose the modification changes of heat treatment [2, 3].

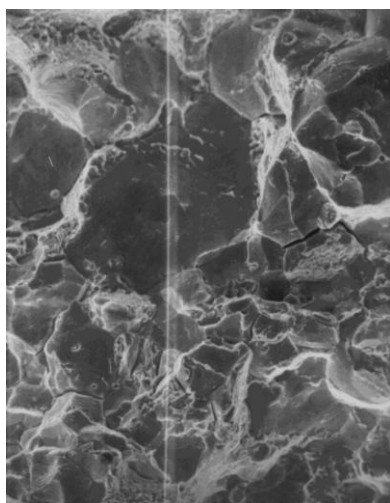
Micromorphology of fracture surfaces of the original crack was formed by IGF rupture. The laboratory fracture of defective rib showed occurrence coarse intergranular facettes in the undersurface areas, where they worked in the breaking of pressure stress (Fig. 6). The remaining part of fracture was formed predominantly by transgranular quasi-fissile (TGQ) rupture (Fig. 7). In relation to suitable of ribs, only TGH fracture was observed (Fig. 8) [2, 3].

*Fig. 6 IGF frac. zoom.: 320x [2]*

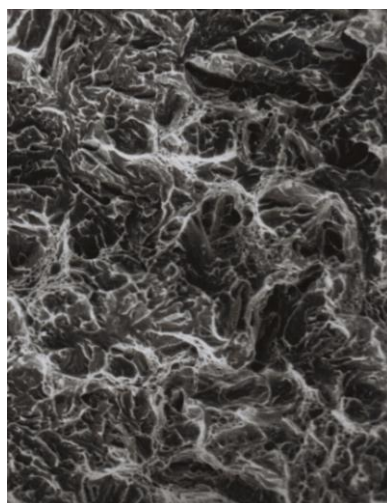
*Fig. 7 TGQ frac. zoom.: 320x [2]*

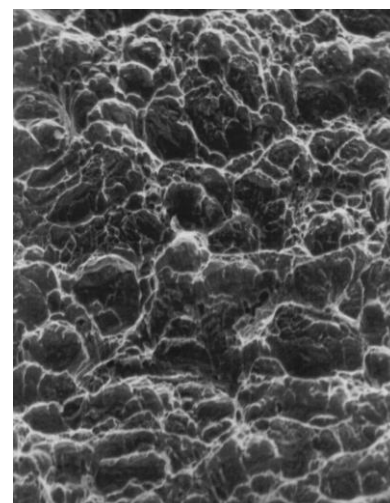
*Fig. 8 TGH frac. zoom.: 320x [2]*

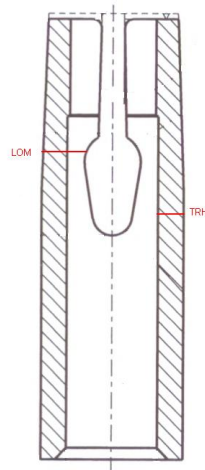
**Fig. 10** Drawing of collet with emphasized fracture and crack

The collet rupture occurred in short time after starting of its operation. After selecting the collet from the case, it was found that one of the so-called arms was broken off. The microscopic evaluation released the crack of another so-called arm and the given crack was spread from outer side of collet (Fig. 10, 11) [4].

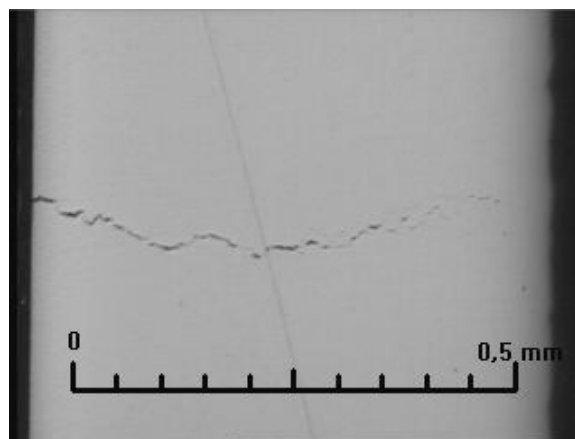
**Fig. 11** Progress of crack in the unbroken part [4]

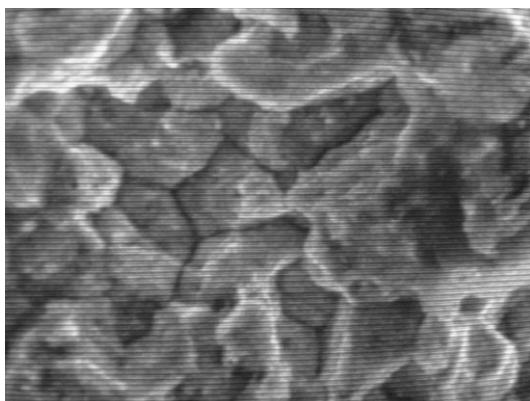
The microstructure is composed of low-hardened martensite and fine globular carbides [4]. Micromorphology of operating fracture was formed only by IGF rupture (Fig. 12). Fracture surface was prepared by laboratory breakage of collet rest and this fracture surface was formed mostly by low-energy transglobular hole (TGH) rupture, while the presence of intergranular facettes were not observed (Fig. 13) [4].

**Fig. 12** IGF fracture zoom: 1500x [4]

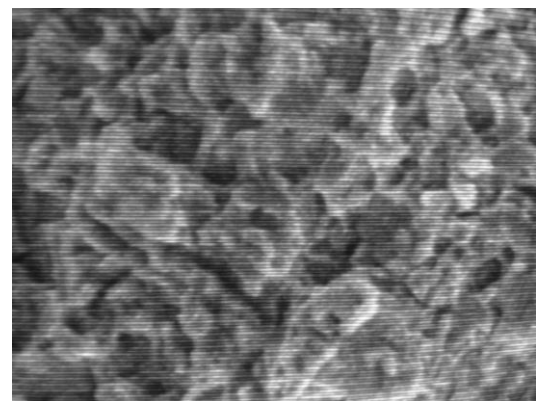
**Fig. 13** TGH fracture zoom: 1500x [4]

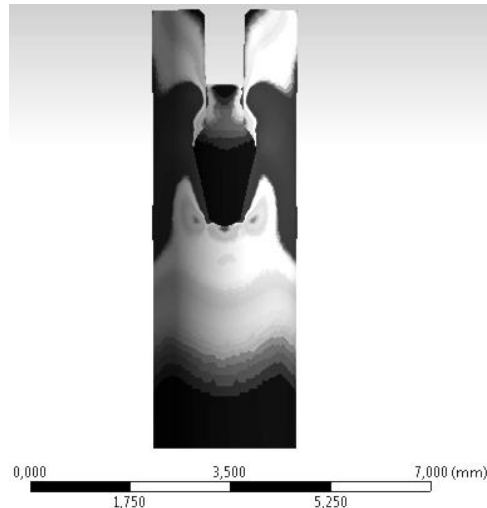
Using analysis of finite elements method (FEM), it has been confirmed, that the component is loaded in bending after insertion of drill into the collet. Comparing places of the fracture, and cracks with FEM model, it was confirmed that the fracture and crack were found in places with the greatest stresses during the exploitation (Fig. 14). On the base of the obtained results, we conclude that a rupture of components was caused by unprofessional handling of the device.

**Fig. 14** FEM model of collet with stress conditions
