APPLIED EXAMPLE FOR REM USAGE AS A TOOL FOR QUICK AND OPERATIVE ANALYSIS OF DEFECTIVE COMPONENT

Ján BEZECNÝ* - Igor BARÉNYI – Mária LIČKOVÁ

¹ Faculty of Special Technology, Alexander Dubček University of Trenčín, Pri Parku 19, 911 06, Trenčín, Slovakia

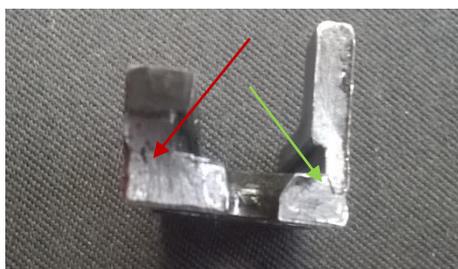
2 Description of defective components

Fig. 1 Broke component with places of fracture initiation

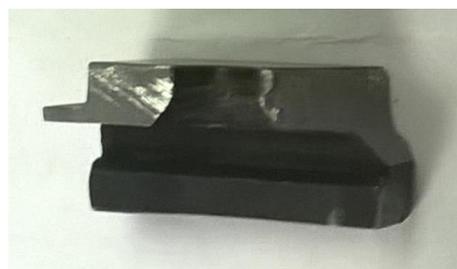
Fig. 2 Laboratory fracture

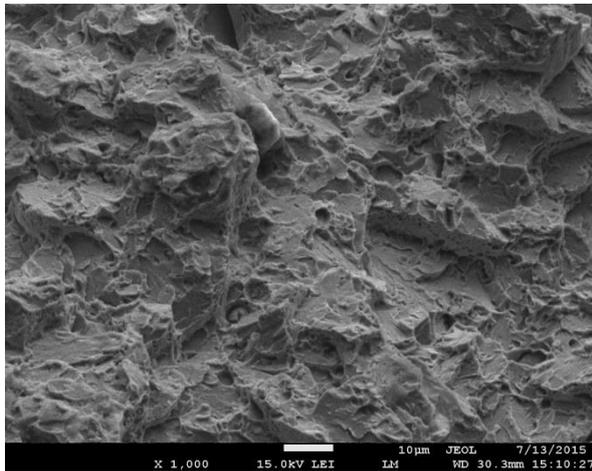
Two fracture surfaces of two samples cut from operational fracture in assumed places of break initiation and one laboratory fracture surface were evaluated in fractographic analysis. Micro morphology of laboratory mostly consists of transgranular quasi fissible (TKQ) and partially of transgranular foveal fracture (TKJ). The presence of brittle intergranular foveal facettes was not observed. (fig. 5 and 6). Observed fracture micro morphology is typical for fracturing of bainite or low tempered martensite.

Fig. 5 TKQ fracture

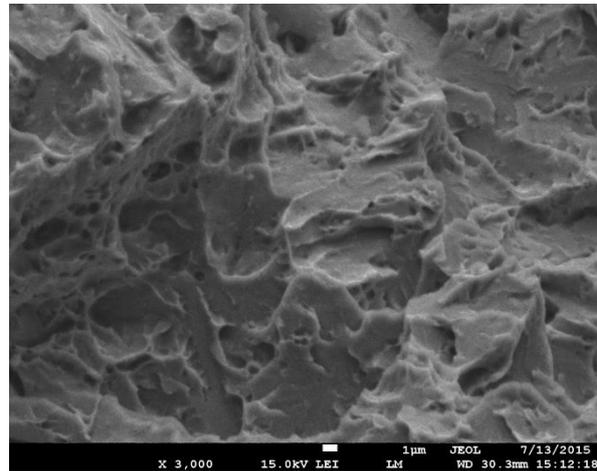
Fig. 6 TKQ fracture

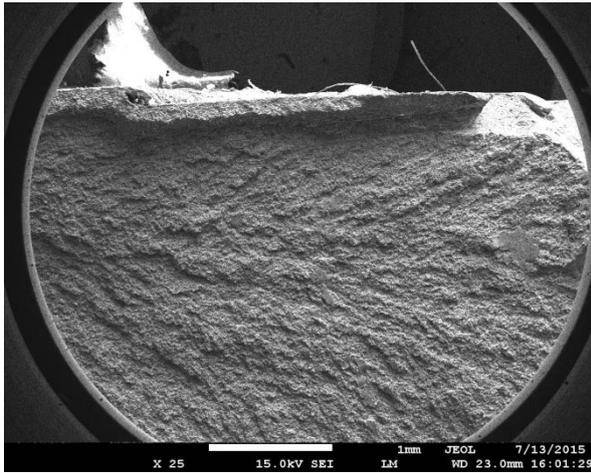
Macro morphology of the samples is documented in fig. 7. There is observed morphological different “strip” in upper part of the sample with depth about 0,1 mm copying whole profile of gouge (fig. 8). The place of fracture initiation is pointed with arrow. More detailed control of fracture micro morphology is shown brittle IKS facettes (fig 9. and fig. 10). There were observed TKQ and TKJ mechanisms similar to laboratory fracture in remaining areas of the sample (fig. 11 and fig. 12).

Fig. 7 Macro morphology

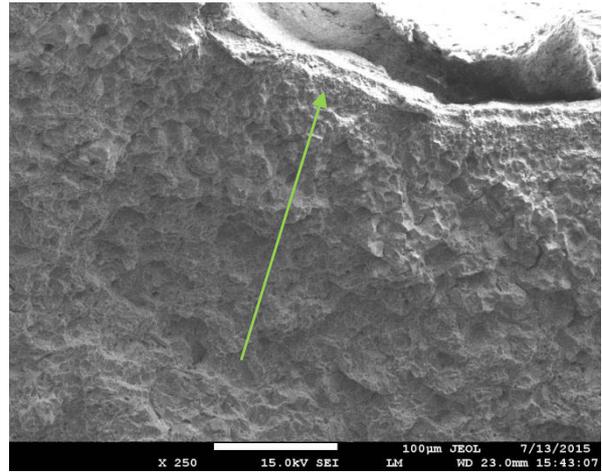
Fig. 8 IKS fracture

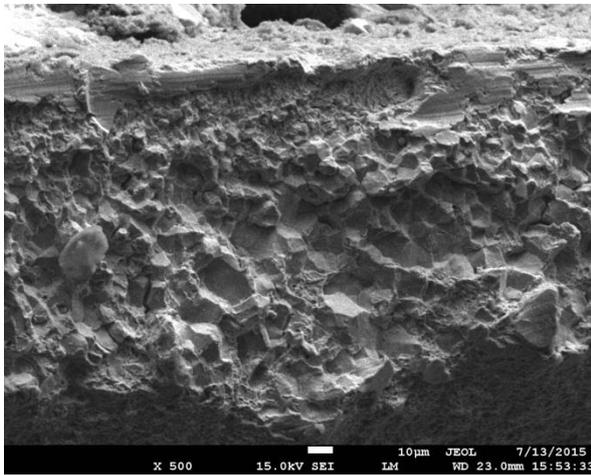
Fig. 9 IKS fracture

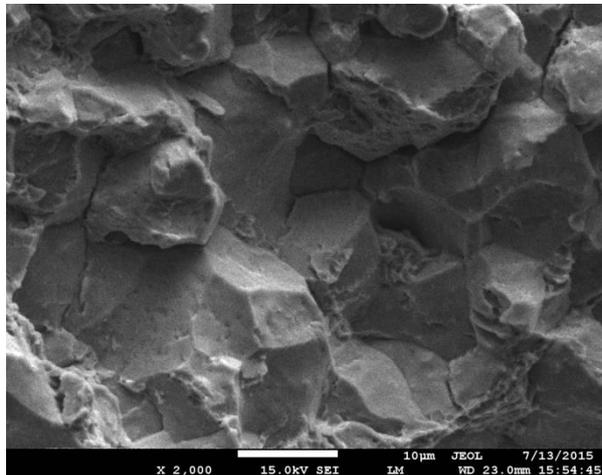
Fig. 10 Detail from figure

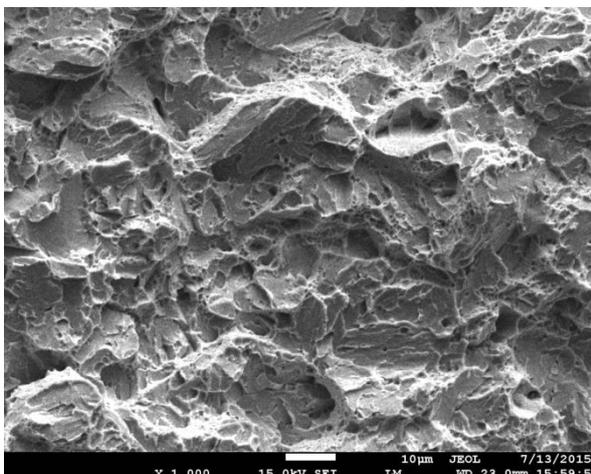
Fig. 11 TKQ + TKJ fracture

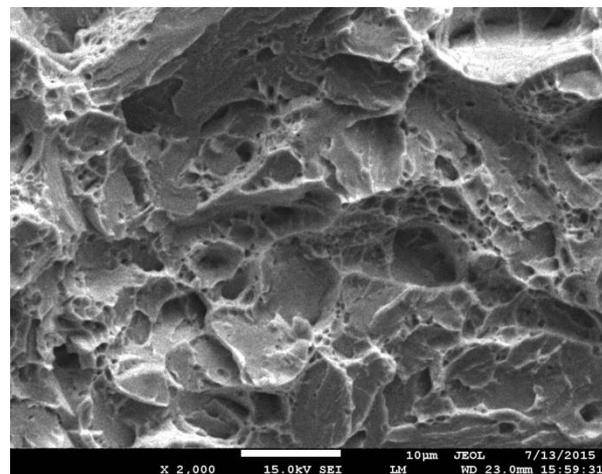
Fig. 12 TKQ + TKJ fracture

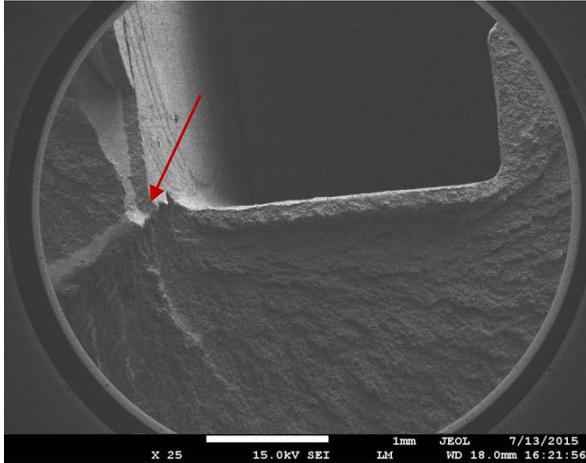
Micro morphology of fracture on sample 2 was similar to sample 1 and is documented on fig. 13, fig. 14 and fig. 15.

Fig. 13 Macro morphology

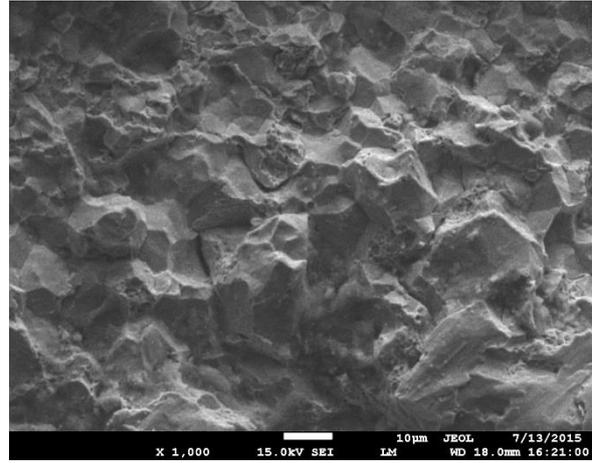
Fig. 14 IKS fracture

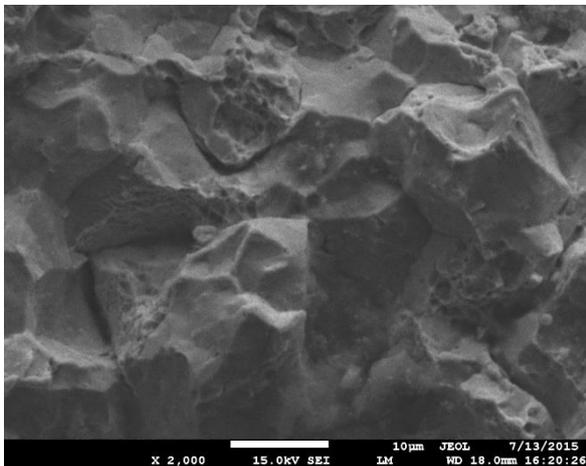
Fig. 15 IKS Fracture

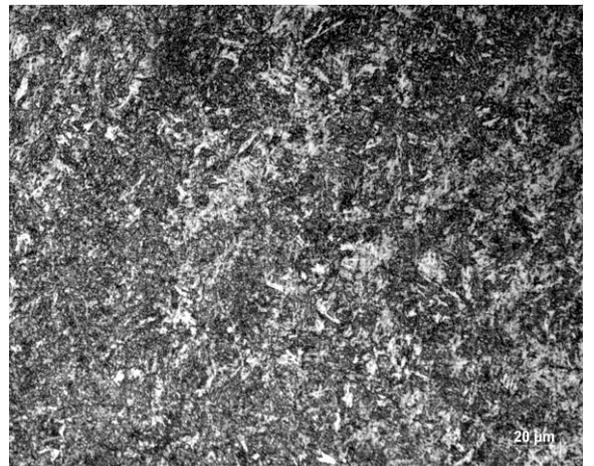
Fig. 16 Microstructure of sample core

Additional metallographic analysis proves carbonization of surface layers (fig.16) and its mostly bainitic structure in the core (fig. 17).

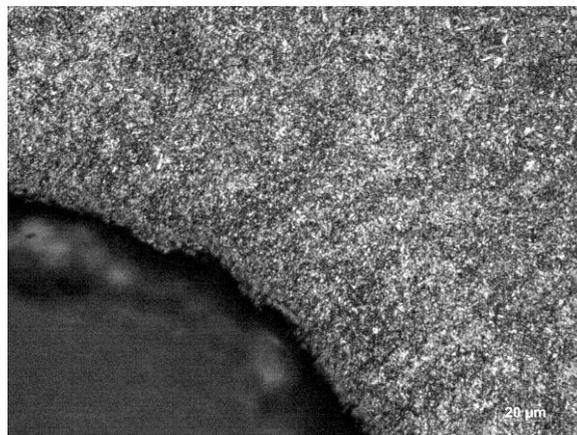
Fig. 17 Microstructure of carbonized layer
