# ROTARY SEAL OF TURBOCHARGER AND THE REASONS OF ITS MALFUNCTIONS

Jozef DOMAN

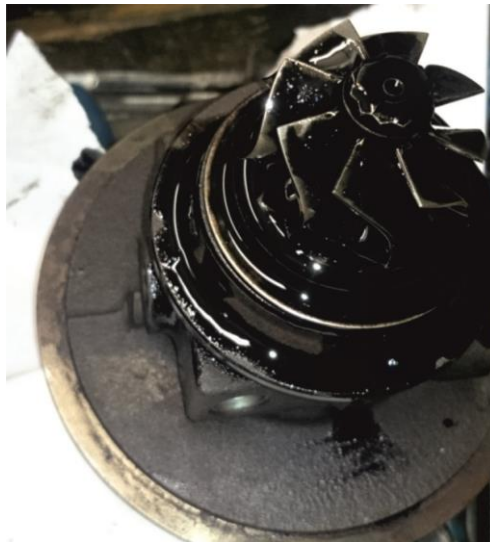
*Fig. 2 Turbocharger with damaged rotary seal*

To assess the situation and the consequences of failure to view rotating seal turbocharger, it was sufficient to show turbocharger partly, without the turbine housing (Fig.2). From the picture we can see that, in the turbine housing began to leak more lubricating oil. The presence of lubricating oil is proved by a layer of certain thickness (black) deposited on the inside surfaces of the turbine. Because the described fact is related to the turbocharger turbine, the operation of which depends on temperature, flow rate and pressure of the exhaust gas of the internal combustion engine, comprises a layer of certain thickness other than the lubricating oil, and deposition of exhaust gas, prevent to infiltration of the lubricating oil (between different cabinets) in the places

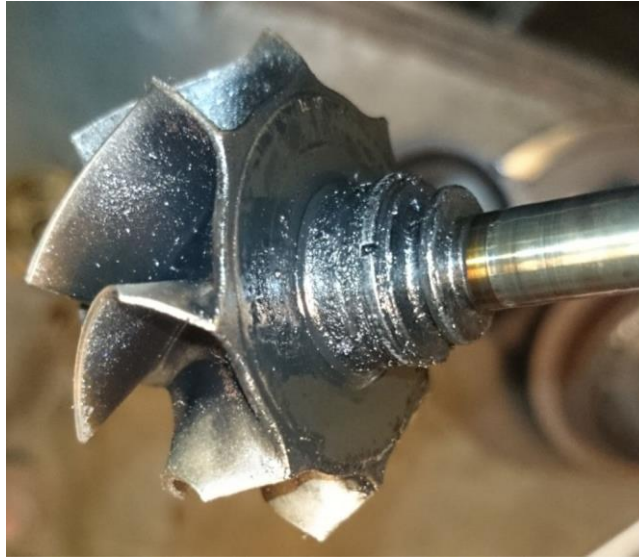
*Fig. 3 Impeller of turbine with shaft*

Fig.3. illustrates impeller of turbine rotor with shaft of a turbocharger, which has already been described above. Also here you can see a layer of certain thickness (black - blend of lubricant oil and sediments from the exhaust system) deposited on the surfaces of the impeller and partially extending into the transition between the wheel and the shaft (a place to housing a rotating impeller turbine seal). Rotating seal of the impeller of the turbine is a seal of circular shape with a rectangular cross section in the center in the axial direction by cutting the seal (so-called. lock) [3]. At the production of rotary seals the metal material from the group of super alloys was used. The cause of penetration of lubricating oil from the housing of the bearing, via the sealing faces of the rotary seal into the turbine housing, there was the decrease of ability to closely (in the case described rotary seal was not able to prevent large-scale penetration of lubricating oil) rotating seals of impeller turbines and up to a level that larger the amount of lubricating oil received in the turbine during operation of the turbocharger in full operation. The role of each of the rotary seals designed for application of turbochargers is to prevent the penetration of lubricating oil in some places, while it is recognized as the design and lubrication, sealing material used and other factors, a certain amount of penetration (small volume) of lubricating oil in the above locations during the operation of the turbocharger after a certain number of operating hours.

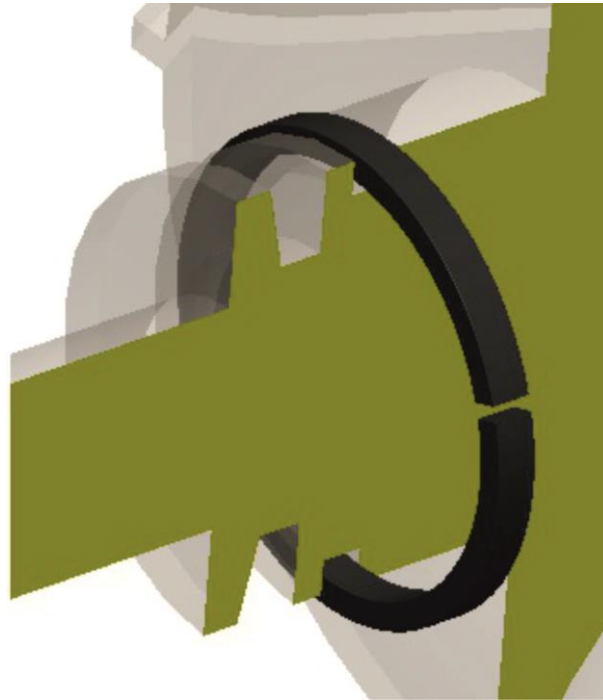
*Fig. 4 Rotary seal of the impeller turbine*

From Fig. 4 that the sealing faces of the rotary seal representative of the external and internal circumferential surface of the seal. Such shape of seal is suitably designed for turbocharger described. Still, there is the possibility to make the design changes of the rotary seal, which may provide a smaller amount of lubricating oil through the imbued sealing surfaces, the ability to extend the operation of a rotary seal, the ability to create a self-cleaning of the sealing surfaces from dirt, and so. The theory of calculation of the rotary seal there is a metal in order to modification the original seal, or draft a new rotary seal turbine impeller. Design for a new rotary seal provides only one way of dealing with disorders described turbocharger. Other possible solutions disorders also have a major character. Basic dimensions of a rotating metal seal are determined according to the literature.

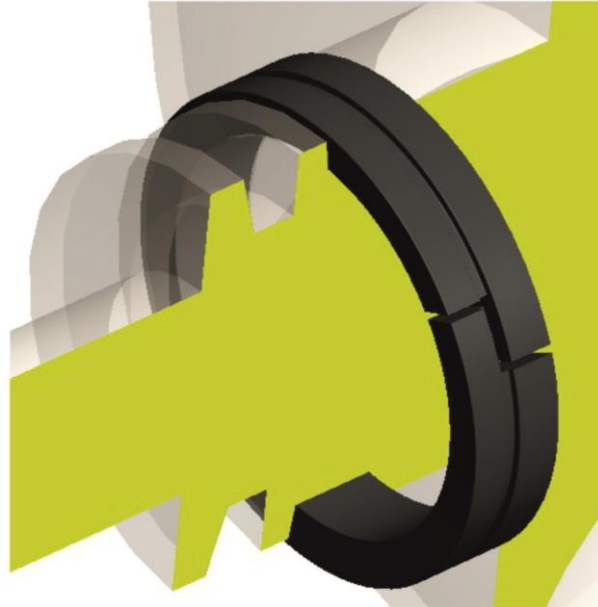
*Fig. 5 Rotary seal impeller of the turbine – design*

Looking at Fig. 5 we can see certain basic shapes of rotating seals. The outer surface of the rotary seal received of the design a larger number of sealing surfaces and circumferential grooves. On the side surfaces of the seal precipitate rised that (trapezoid shape). In the middle, in the axial direction of the rotary seal cutting rised (so-called lock) [3], which has the shape of S. The purpose of the slit shape change, compared with the original seal was to reduce the risk of penetration of lubricating oil in the described location. A prerequisite at the design of rotary seal in addition of improving the ability to seal, it was necessary to ensure self-cleaning of sealing during operation of the turbocharger. This stems from the fact that can be seen in Fig. 3. Pollution by deposits on the functional stretches of rotary seals as an option, it could cause a described malfunction of the turbocharger. The task of the grooves and chamfers is preventing clotting or parties affect deposition of sediments sealing in some places, but also in places of the housing and shaft (seat of rotary seals). Diversity in the forms designed rotary seal and the original Fig. 6 shows rotary seals.

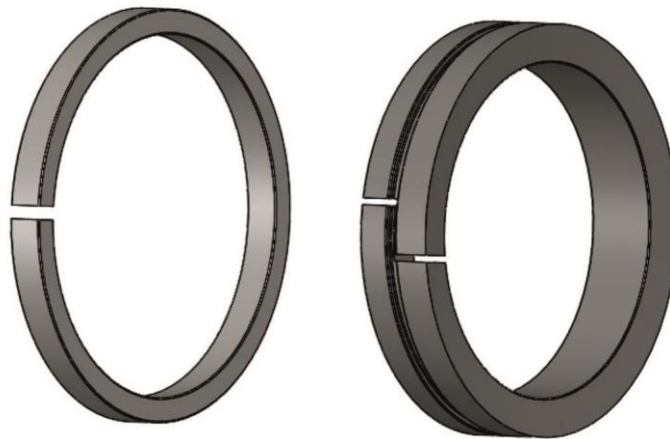
*Fig. 6 Comparison form of rotary seals*

The comparison shows, that the shape of the designed seal has the certain assumptions, that meet its purpose functional properties. During designing of the new seals there are changed in a comparing with the original seal, some seal dimensions (width, internal diameter) to secure the previously mentioned criteria. If the design seal is used for turbocharger described, there will be a need for construction change to the turbine impeller (place of seats seal) and the bearing housing of the turbocharger. In addition, there is a need for further changes attributable to changes in the dimensions of the proposed seal on the original seal. Resize causes a change in resistance of the friction surfaces of the rotary seal turbine impeller.
