## DEFECTOSCOPIC DEFECTS RAILS FOR RAILWAYS AND PURPOSE CRACK DETECTION

Eva BREZOVÁ<sup>1\*</sup>

<sup>1</sup> Ing. Eva Brezová, Alexander Dubček University of Trenčín, Faculty of Special Technology, Pri Parku 19, 91106 Trenčín, Slovakia

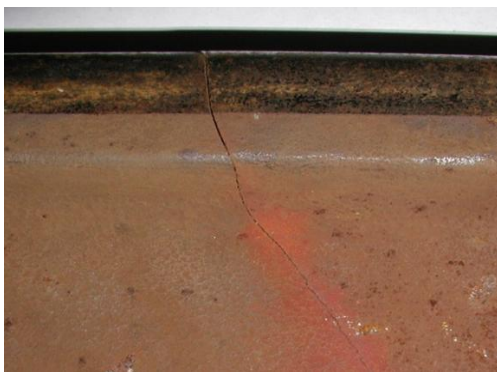
Fig. 1 transverse cracks

Passage trainsets exposes errors rail vibrations that can cause enlargement (growth) errors due to contact fatigue. At low temperatures and their respective thermal stress critical defect size increases the rail such that the rails fractures are more common in winter. The crack increases exponentially, and so reduces the cross-section of the rail at that location, which significantly reduces its strength.

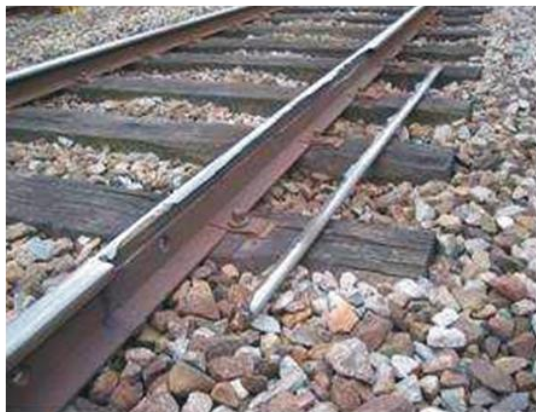
Cracking spreads in the direction of the length of the rail

- Related to the production process rails (rolling in the production process)
- A frequent occurrence in older types of rails
- Development defects in two phases

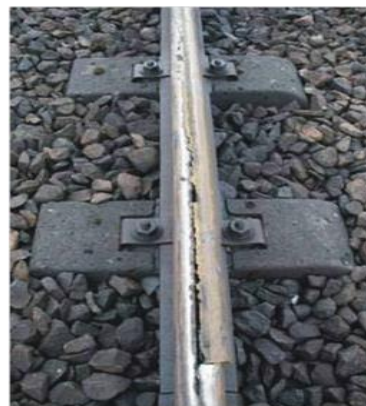
Cracking reaches surface

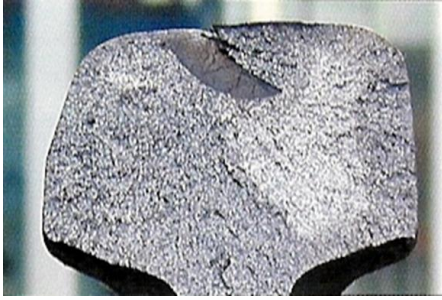
*Fig.6 this shows the development of a crack*

- short (fine cracks, sometimes together with gray patches, cracks of up to 10 mm)
- medium (slightly enlarged number of gray spots and cracks length 10-19 mm)
- long (large number of gray spots and cracks length 20-29 mm)
- critical (extremely large number of gray spots and cracks with a length of 30 mm)

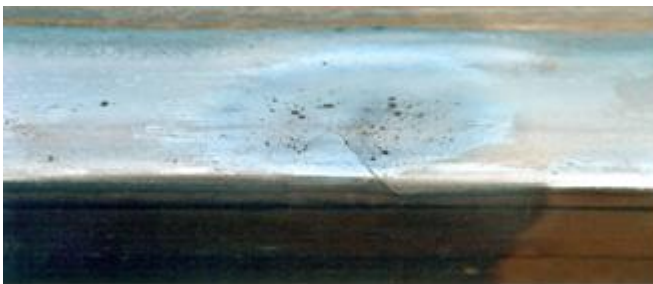
*Fig.8 Squats - A typical crack formation in the shape V of a tread in the railhead*

This defect is common in tracks catering to high speed passenger trains with low axle loads. It is found both in straight and moderately curved track. The first superficial indication of the failure is appearance of fine surface cracks located at the Gauge side of the running band and lying at an angle of 45 degree to the forward direction of traffic in plan view. This is followed by the appearance of dark spot on the running band. The depression will be up to 1.6mm and cause higher dynamic wheel/rail forces.

Information on the origin and evolution Head checking are also valid for Squats, but Squats critical defect size is important.

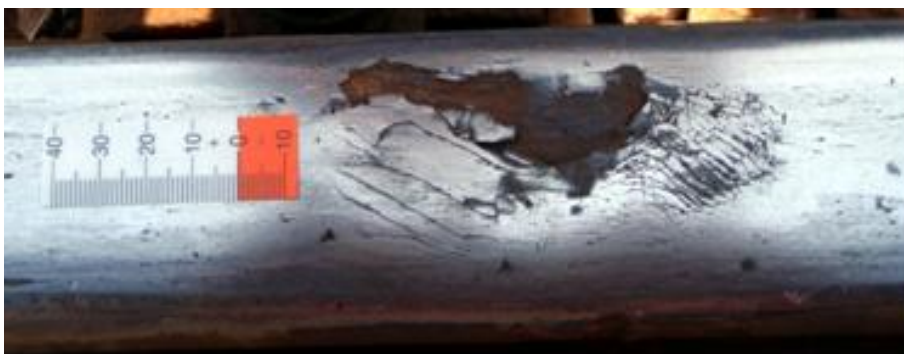
Fig. 9 example defect wheelburns

Wheel burns are the result of frictional heating produced by a spinning wheel set. Wheel burn the drive axle gives rise spontaneously turbid spots. The incidence especially in stretches of track where there are repeated starting off and braking railway vehicles. There is a gradual grinding material. This stain may disappear over time or may develop horizontally or diagonally in the railhead.

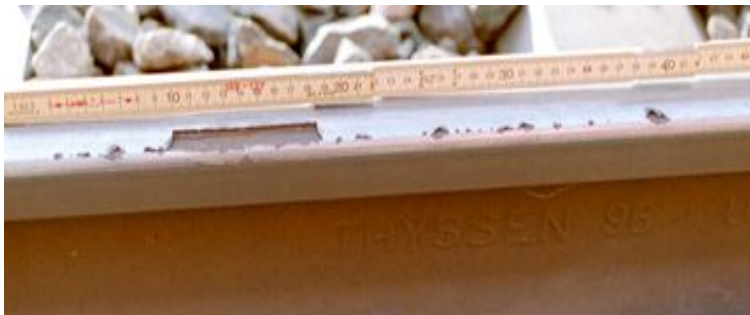
*Fig. 10 example Shelling in the final stage*

Defect shelling is initiated from the internal defects of manufacture. In the early stage development of dark spots longitudinal, particular external rail strips in curves. Advanced development phase error is a separation of the tread and considerable local recess tread. The final development phase defects represents the formation of transverse cracks (often with their rapid development), leading to fracture rails. Removal can only exchange the rails.

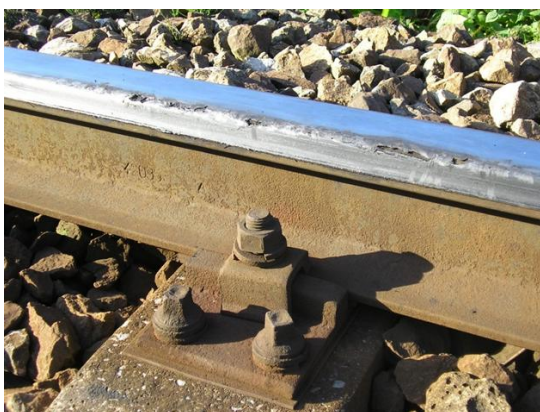
*Fig.11 shelling on the rail*
